CONNECTICUT RIVER BASIN NORTHFIELD, MASSACHUSETTS

SAWYER POND DAM MA 00050

PHASE I INSPECTION REPORT
NATIONAL DAM INSPECTION PROGRAM

MARCH 1981

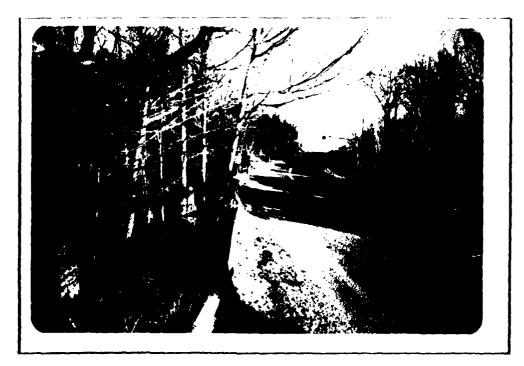
1. VIEW ALONG THE TOP OF THE DAM FROM THE LEFT ABUTMENT (12/4/80)

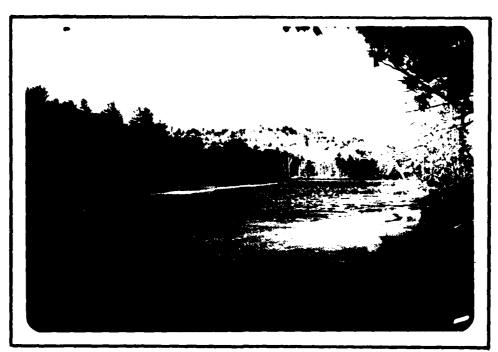
4. SAWYER POND LOOKING UPSTREAM FROM THE DAM.(12/4/80)
